BELZONA KEEPS THE SHOWERS HOT & CLEAN AT HOTEL

International Hotel, Malta

August 2005

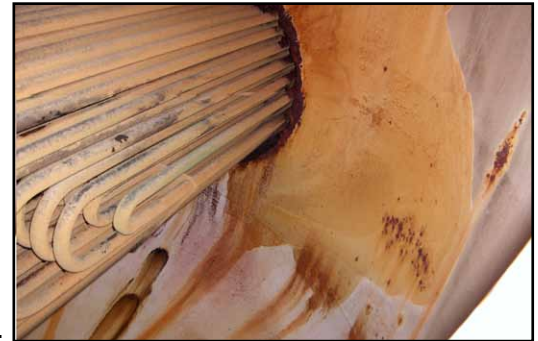
Breakdown of the original coating system had resulted in severe corrosion, deep pitting and through holes around the heating bundle. In addition the corrosion led to discolouring of the hot water supply in this prestige international hotel, leading to customer complaints.

1. Corrosion damage after failure of the original coating
2. Tube bundle nozzle, before preparation for coating
3. Completed application
4. Inspection after 8 months in service
