PUMP BELL CASING REPAIRED AND PROTECTED WITH A LONG TERM BELZONA SOLUTION

Sea water cooling system pump for a 60 MW turbine.

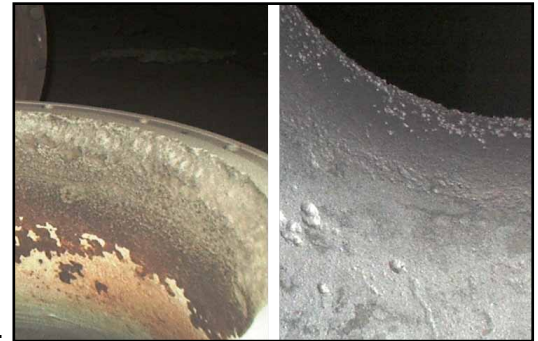
Efficiency losses and pump breakdown due to severe erosion-corrosion of the single vertical axial flow pump (7090 m³/h). Prior to the Belzona solution the client had to replace or repair the pump components annually. As a significant local electricity supplier, downtime of this critical equipment caused major problems.

1. Original system after 1 year in service
2. The finished Belzona application
3. Cavitation damage in the swept area
4. Ready to go back into service after touch up

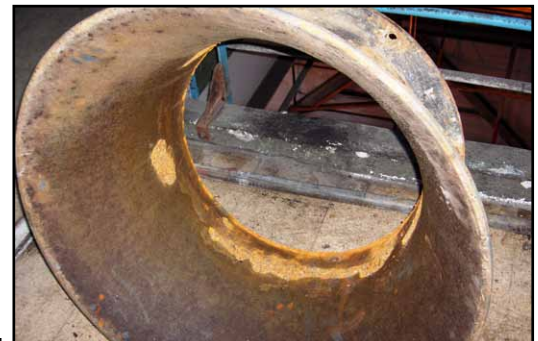
The original bell lining was failing on an annual basis, leading to pitting corrosion and regular replacement. The Belzona repair vastly improved reliability and performance. The pump casing, liner and diffuser were also repaired and coated, internally and externally. Yearly touch up is required of the sacrificial coating in the swept area due to cavitation damage. original Belzona protected bellmouth still in service after nine years.
