BELZONA SEALS LEAK IN OIL STORAGE TANK

Power Station, Ravenna, Italy

Oil storage tank

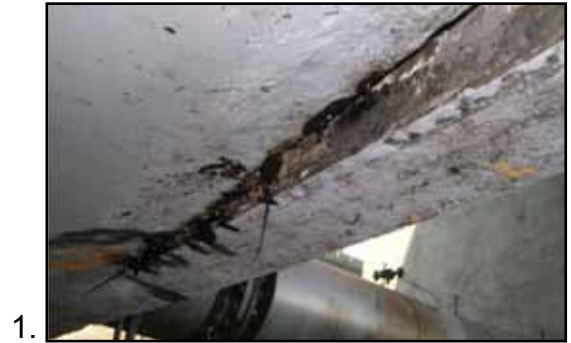
Corrosion of the metal flooring caused a severe leakage of oil into the environment. Welding was not possible.

1. View of the leakage after the area was blasted
2. Belzona 1161 being applied
3. Belzona 1111 applied on the metal plate
4. Positioning and fixing the metal plate with clamps and adjustable risers
