BELZONA HELPS UNDER FIRE

Cement Company, Miami, FL

Bauxite Bin and Raw Mill

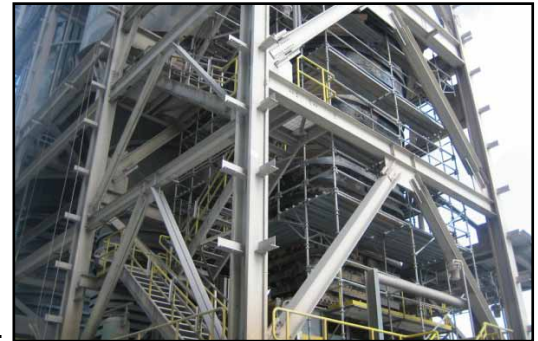
This is a very corrosive environment due to the nature of the raw material and the high temperatures used in the process led to serious corrosion on the plant. A serious fire, However, accelerated the situation and the bauxite bin could not be used anymore, forcing a shutdown at the plant.

1. Bauxite Bin After The Fire
2. Raw Mill after application of Belzona® 3921
3. Bauxite Bin during first coat of Belzona® 5111
4. Bauxite Bin after completion of the application
