BONDING FAIRLEADS WITH BELZONA

37 Meters long Yacht

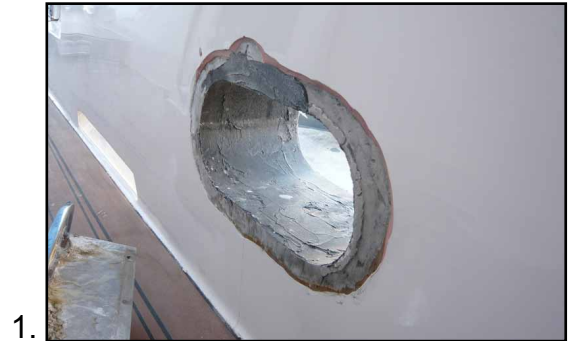
1. Fairlead pocket
2. Fairlead before application
3. Application underway
4. Fairlead clamped in place during the cure process
