## BELZONA LEVELS AND PROTECTS ERODED CONCRETE

Chemical Plant, North Alabama, USA

2001

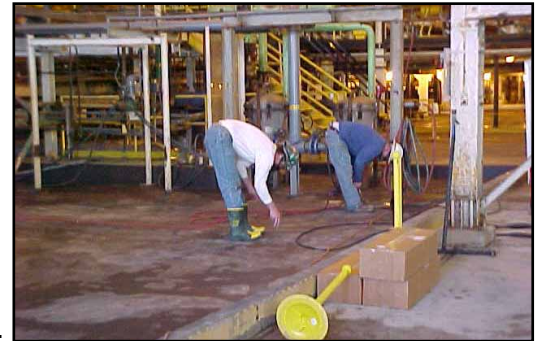
Acids and caustic mixture had eroded the concrete and EPA made the client repair the concrete so Mercury would not accumulate on the floor.

1. Overall view of the containment area
2. Using slurry mix of Belzona® 4111 to level low areas
3. First coat of Belzona® 5811 with non-slip aggregate
4. Final coat of Belzona® 5811
