## BELZONA KITCHEN REPAIR KEEPS THE STUDENTS GOING

University, France

Kitchen serving the restaurant for the University students.

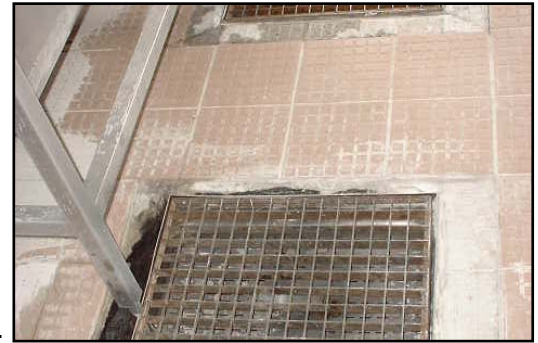
1.

The tiles were degraded around the stainless steel grate. Following a health and safety inspection, the hygiene of the kitchen was reported so urgent action needed to be taken.

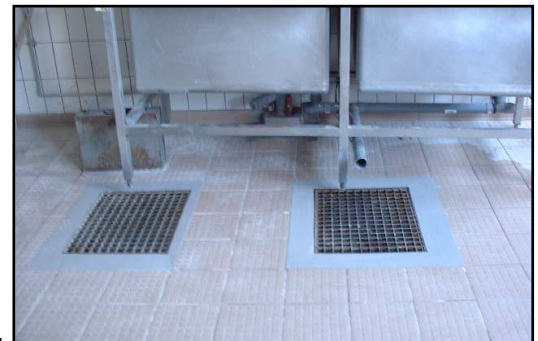
3.

The Belzona solution offers several advantages to the customer. The excellent adhesion onto different substrates (metal, concrete & tile). The easy to clean surface, proven to be a hygienic solution. It is also resistant to the cleaning liquids used. The Belzona® 4111 is resistant to the pedestrian & trolley traffic in this environment and after 5 years in service, the repair is still in perfect condition.

The application was carried out following the Belzona Know-How System Leaflet FPA-1.
