BELZONA MAKES GRIT TRUCKS FIT FOR THE WINTER

Screw auger from a road gritting truck

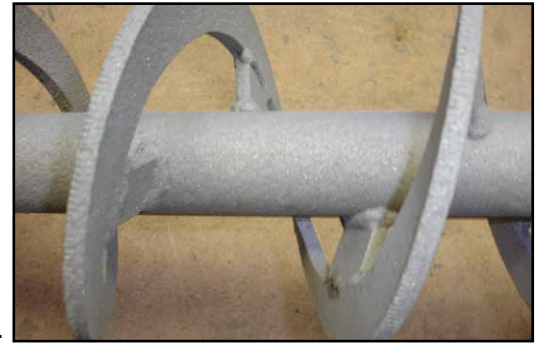
1. Auger screw after grit blasting
2. Application of the first coat of Belzona® 1321 (blue)
3. Finished first coat
4. Finished application with second coat of Belzona® 1321 (grey)

The application was carried out in accordance with Belzona Know-How System Leaflet SHM-14. Two coats of Belzona® 1321 were applied to the grit blasted steel substrate.
