## BELZONA RESCUES KOMATSU LOADER

Komatsu transmission casing

Loader drove over rock and cracked the casing in many areas

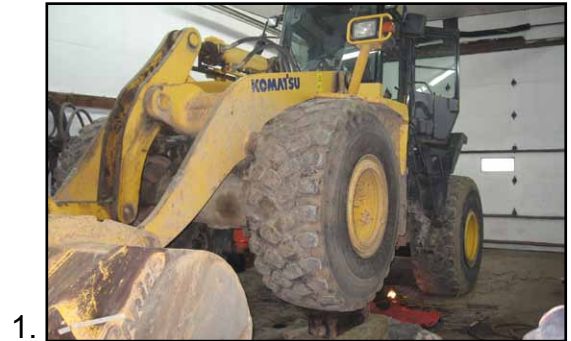
1. Loader
2. Cracked transmission casing
3. Preparation of casing
4. Belzona 1161 after application

After trying welding the cracks the oil in this casing continued to leak. That's when Belzona 1161 came to the rescue. Cost of repair \$1500 vs Komatsu dealer repair over \$20,000. Loader still running after 10 months of operation maintenance free.
