## BELZONA REBUILDS TURBO SEPARATOR

Pulp & Paper Plant, Bulgaria

Turbo Separator ATS21

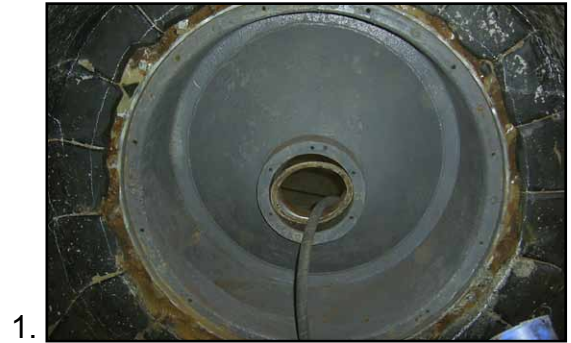
The basalt tile lining suffered severe abrasion during pulp separation and as a result a lot of broken edges and cracked tiles were present.

1. View of the damaged tiles around turbo separator outlet
2. The same view of the outlet after grit blasting
3. Belzona® 1811 applied to restore damaged tiles
4. Close up view of the repaired separator inlet
