## RESEATING NEW RUDDER BUSH WITH BELZONA

Ship Dockyard, Bulgaria

Installation of new pintle bearing bush in worn pintle bearing housing.

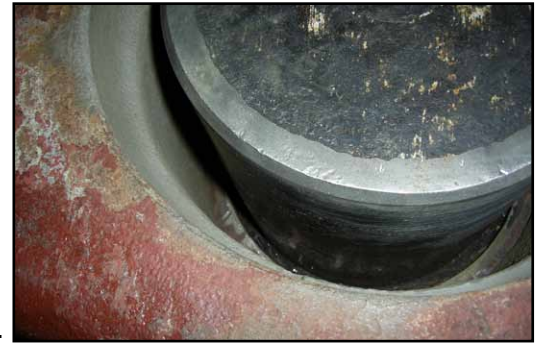
1. The housing prepared by blasting and ready for bush assembly.
2. The new bearing bush prepared with thread profile and longitudinal channels to accommodate plastic pipes for injection and to serve as locking keys to prevent bush rotation.
3. Sealing the bottom of the new bush with Belzona® 1221.
4. Completed application. Belzona® 1321 completely filled annular space. Pintle with metal shims were used for bush alignment.
