SUCTION BELLS RESTORED WITH BELZONA

Power Plant, Missouri

Suction bells from two cooling water pumps.

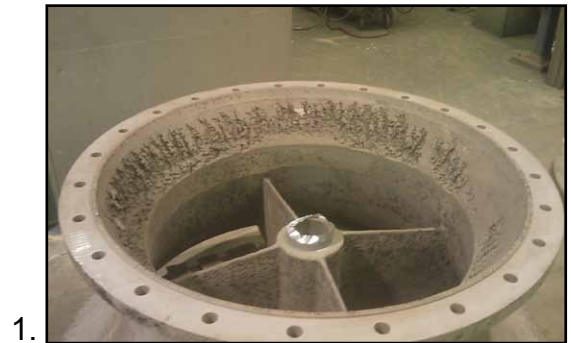
Erosion had caused serious loss of metal with holes completely through the substrate in places. Loss of efficiency and unscheduled downtime lead client to look at replacing the items.

1. Erosion clearly evident
2. Belzona® 1311 being applied
3. Belzona® 1321 applied to internal surfaces
4. Belzona® 5811 applied to external surfaces
