## CAVITATED PUMP DIFFUSER RESTORED WITH BELZONA

Theme Park, (Southeast) Virginia

March 2009

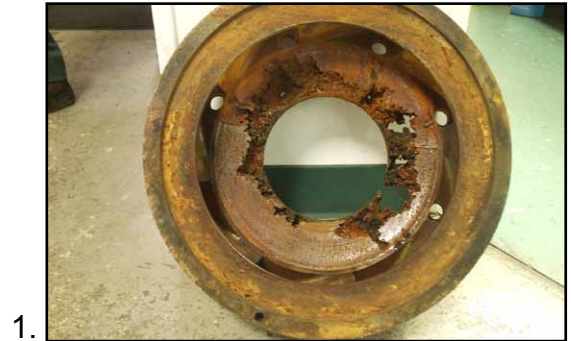
Cavitation had caused severe metal loss to pump impeller and diffuser. New impeller was available but no diffuser available.

1. Severely cavitated diffuser
2. Diffuser blasted and rebar tack welded in place
3. Belzona® 1111 application
4. Completed repair
