## BELZONA PROTECTS 98% SULFURIC ACID CONTAINMENT AREA

Power Plant, Alabama USA

98% Sulfuric Acid containment area in water treatment plant.

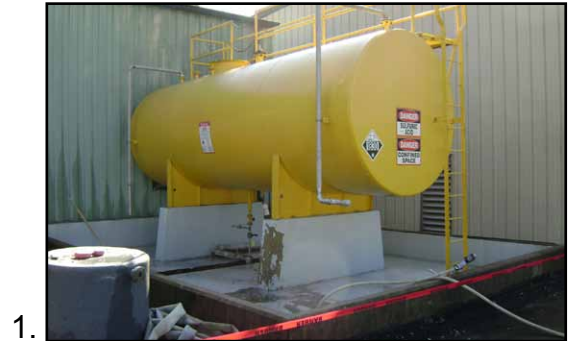
1. Old coating being removed
2. Belzona® 4311 being applied
3. & 4. Completed application

Application was carried out in accordance with Belzona Know-How System Leaflet TCC-15. Old coating was removed using high pressure water blasting. Belzona® 4311 was applied to both containment and tank stands.
