BELZONA RECLAIMS AND PROTECTS SULFURIC ACID BUND

Sulfuric Acid Refinery, Wyoming U.S.A.

850 sq.ft. secondary containment area for 98% Sulfuric acid.

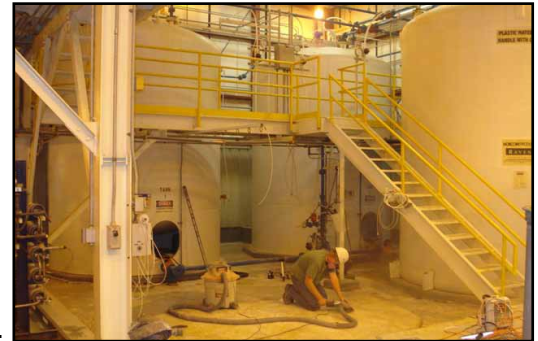
1. Overview of the acid containment area
2. View of the damaged concrete
3. View of area rebuilt and resurfaced
4. Completed job after coating with Belzona 4311

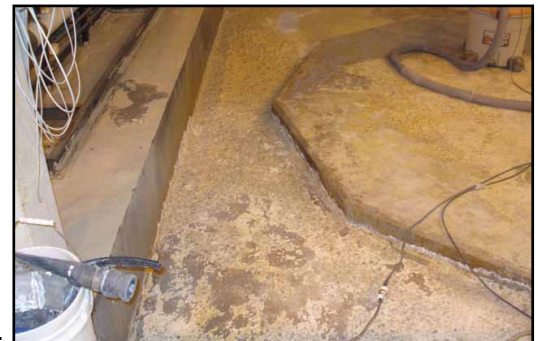
Previous product used gave limited results. Extensive rebuilding of the concrete was needed to allow the containment area to drain to the center sump. This to be followed by an overall protective coating.
