BELZONA REPAIRS POWER PLANT COAL BELT

Power Station, Memphis, Tennessee U.S.A.

Primary belt for the power station to get coal from the river to the point of use.

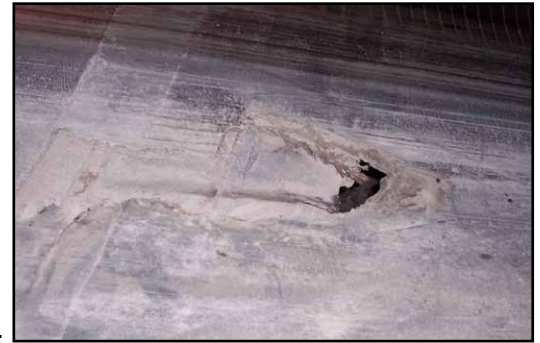
After years of use the belt had developed several holes. If the holes were not taken care of it could cause ripping of the belt, prior to Belzona it would take up to a day for previous repair methods.

1. Damaged belt prior to repair
2. & 3. Repaired belt
