BELZONA REBUILDS LOADER PIN BUSH HOUSING

Metals Recycling Facility, Missouri U.S.A.

April 2008

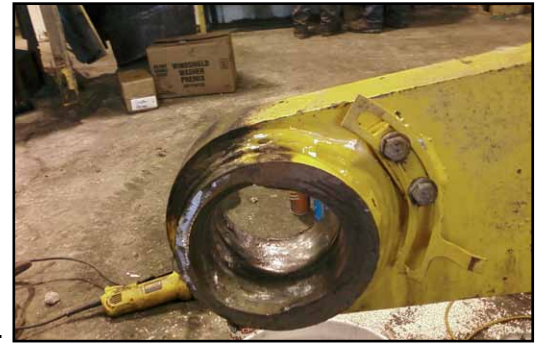
Wear in the pin bush housings. Conventional welding required the loader to be out of service too long.

1. Damaged pin bush housing
2. Surface preparation complete
3. Dummy shaft installed to maintain alignment
4. Finished and ready for service

Repairs were completed in accordance with Belzona Know-How System Leaflet MPT-8.
