BELZONA PROTECTS CHEMICAL CONTAINMENT AREA

Food Processing plant, France

Chemical containment area

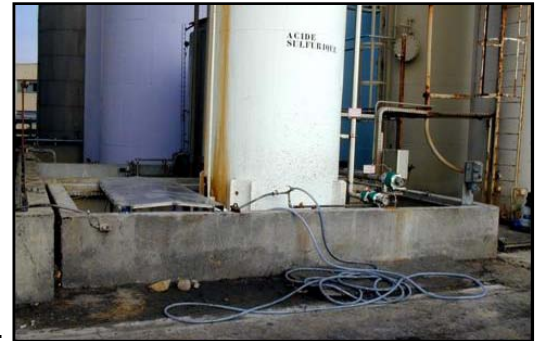
Heavy deterioration of the concrete due to leakage and contamination during maintenance operations. The integrity of the structure was compromised.

1. View before repairs
2. View of the tank supports
3. View after shimming
4. Application completed with Belzona® 4311 applied
