INJECTION OF BELZONA REPAIRS SHAFT

Hydropower Station, Spain

2.9 M diameter Butterfly Valve which controls the inlet water to the turbine.

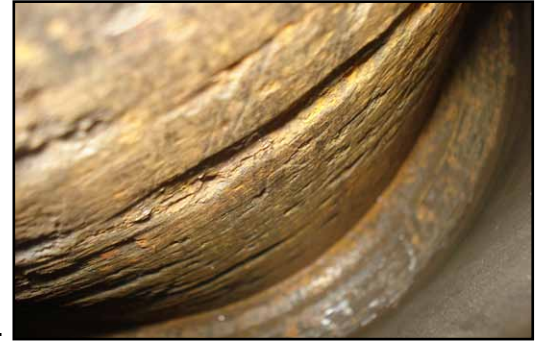
After more than 30 years working, the shaft had severe damage and loss of diameter causing water leaks

1. Original shaft damage
2. Heating the shaft with the former already installed
3. Injecting Belzona between the shaft and the former
4. Shaft rebuilt and protected at the same time
