## BELZONA CREATES PERFECT FIT FOR CRUSHER BUSHING

Lead Mine, Central Missouri USA

The Secondary Crusher.

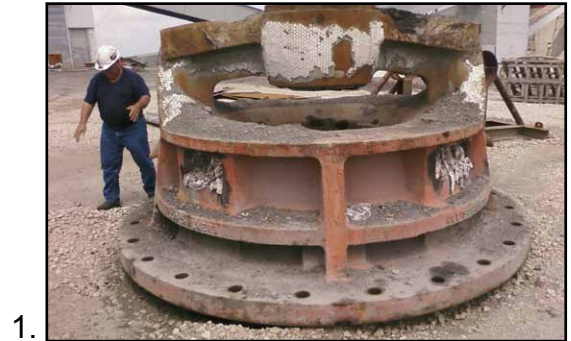
1. Upper Crusher Assembly (note size and weight)
2. Damage to housing I.D and flange surface
3. Release Agent being applied to new bushing
4. New bushing lowered in place with jacking bolts used to position bushing

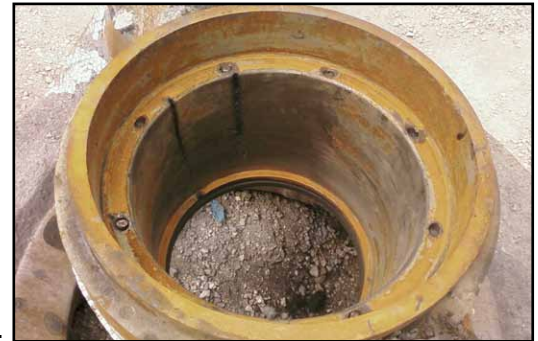
2.

Upper Crusher Bushing seized on crusher shaft and spun inside the housing, resulting in loss of approximately .025" to the inner diameter. Housing suffered additional damage from cutting torch while removing old bushing.

Application was carried out in accordance with Belzona Know-How System Leaflet MPT-7. Belzona® 1111 was used to fill grooves cut by welding torch and Belzona® 1321 to restore inner diameter tolerances using the new bushing re-form the housing.
