CLASSIC BELZONA SHAFT REPAIR AT CEMENT PLANT

Cement plant, Nazareth, PA

Forced draft fan shaft for the kilns.

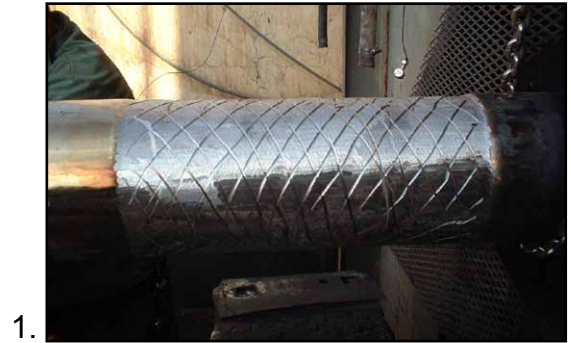
1. Shaft prepared
2. Split sleeve former
3. Rebuilt shaft being measured
4. Back in service

Application was completed in accordance with Belzona Know-How System Leaflet MPT-2.
