## BELZONA ALTERNATIVE TO HARD FACE WELDING

Paper Co. North Alabama USA

A 40 ft screw conveyor handling bark and ash.

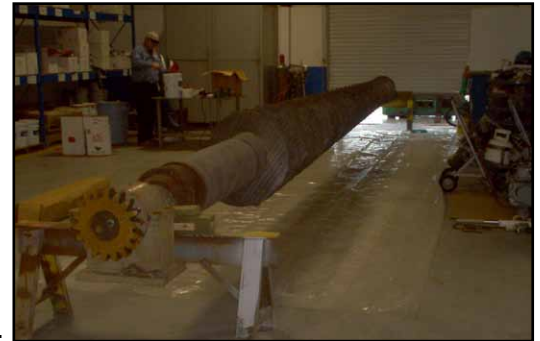
1. Overall view of the 40 ft screw conveyor
2. Screw conveyor with Belzona® 1812 applied
3. Close up of the Belzona lining
4. After 5 years, 75% still OK and was repaired in place

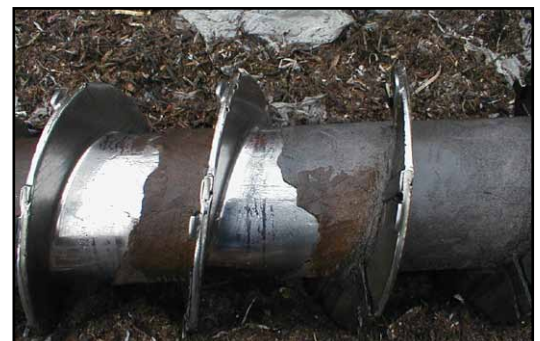
4.

Belzona lasted for over 5 years where the hard facing lasted about the same but was twice the price. Belzona® 1812 can be repaired in place but not hard face welding.
