BEARING HOUSING REPAIR WITH BELZONA

Watersupply company, Bulgaria

Centrifugal pump bearing housing

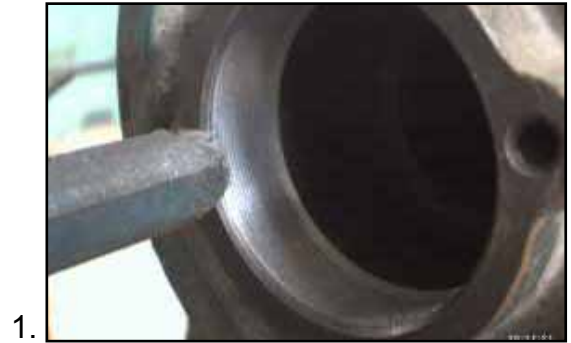
1. Preparing surface
2. Belzona® 1111 applied
3. Housing with restored dimensions after machining

Application was carried out in accordance with Belzona Know-How System Leaflet MPT-6.
