## BELZONA REBUILDS OVERSIZE KEYWAY

Water supply company, Bulgaria

Shaft from double suction split case centrifugal pump.

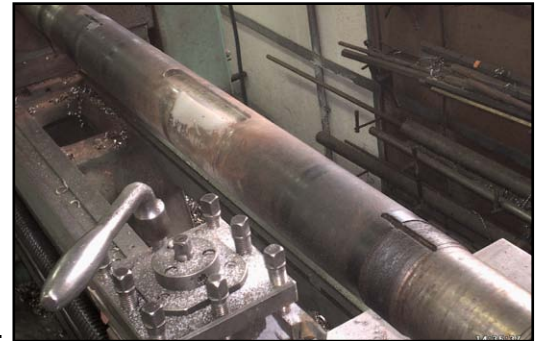
Broken edge of the keyway seat. Insufficient contact area for the load transmission.

1. The worn keyway
2. Surface prepared
3. Keyway being bedded into Belzona
