BELZONA TACKLES SEVERE CUI ON COLUMN

Refinery, UK

Severe Corrosion Under Insulation (CUI) on columns

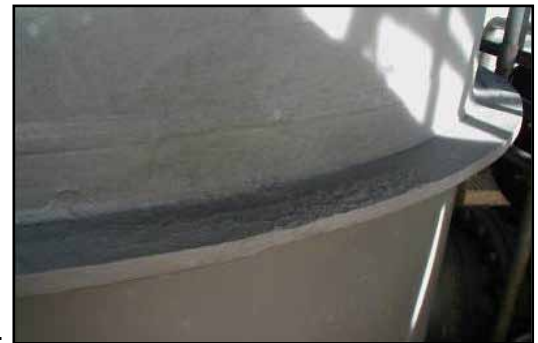
1. General view of refinery
2. Application area after grit-blasting
3. & 4. Completed application

Application was carried out in accordance with Belzona Know-How System Leaflet TCC-5. The Belzona® 5851 was hand applied as a two coat system to grit blasted 8m sections of the column that were then re lagged before moving on to the next section. vessel remained in service throughout the application.
