BELZONA REPAIR TO CLARIFIER SHAFT IS MOLDED

Machine shop, Gulf Coast

Cutlass bearing area on clarifier shaft

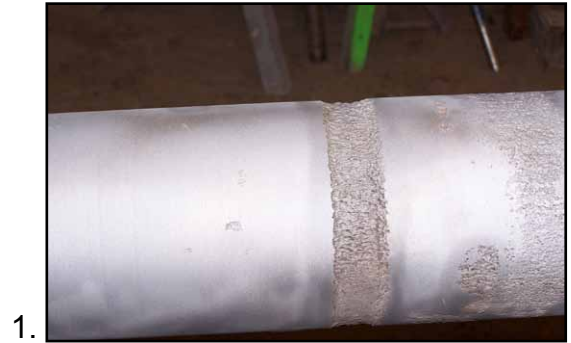
Bearing fit deteriorated due to chemical attack and abrasion. Customer needed clarifier back in service as quickly as possible.

1. The worn shaft
2. Installing the former
3. Injecting Belzona® 1391
4. Finished and shaft ready to put back in service.
