BELZONA ELIMINATES BREACHES IN BLAST FURNACE

Steel Manufacturer, Teesside, UK

Shaft for the Flow Control Gate into the blast furnace.

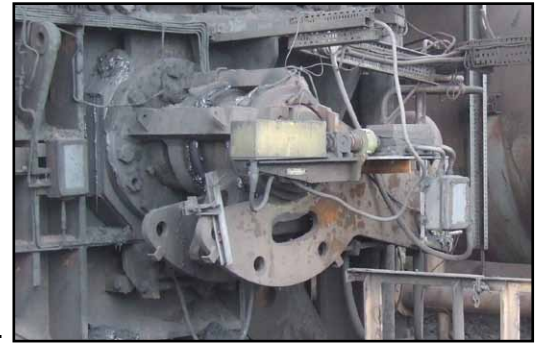
1. Blast Furnace Flow Control Gate assembled
2. Damaged shaft
3. Application of Belzona® 1111 and clamp former
4. Final dressing of Belzona® 1111 before reassembly

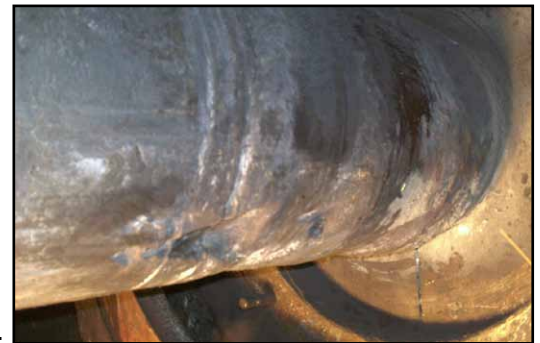
2.

Abrasive dust and gases from the blast furnace had bypassed packings and seals around the shaft for the flow control gate at the top of the blast furnace. Damage had rapidly escalated, creating several grooved rings and severely gouged pits up to 15mm deep, allowing gases to escape, creating a potentially toxic area.
