BELZONA SEALS SF6 LEAKS ON CIRCUIT BREAKER

Gas charged circuit breakers in sub station

SF6 gas leaking through porcelain bushing seals

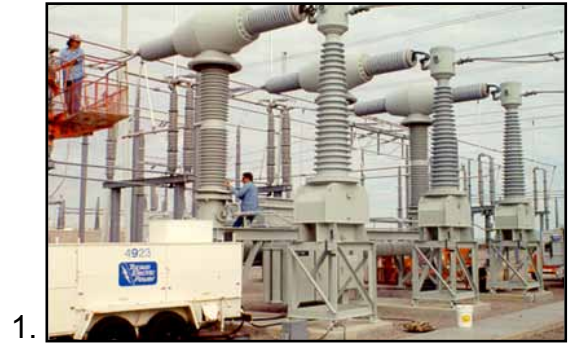
1. General view of the repair area (Top and Bottom)
2. Top bushing sealed
3. Bottom bushing sealed

Application was carried out in accordance with a modified Belzona Know-How System Leaflet ENC-10. Following surface preparation to profile the metal and remove the glaze from the porcelain Belzona® 2311 was used to create an elastomeric seal.
