## SEALING TRANSFORMER OIL VALVES WITH BELZONA

Electricity distribution, Vitoria, Spain

Oil valves feeding a transformer at substation.

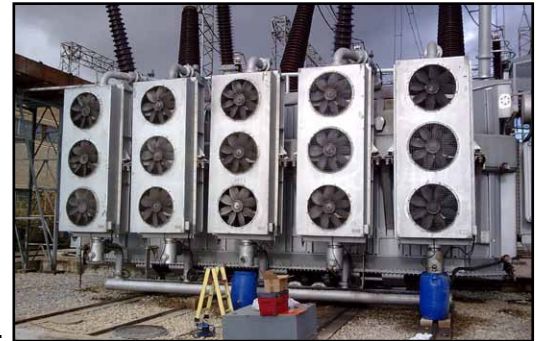
Valves were leaking oil due to a defective flange seal.

1. General view of the location for the unit
2. Cleaning the application area.
3. Final result after application of Belzona 1161
