NOVEL REPLACEMENT OF GUTTER IN CHEMICAL PLANT USING BELZONA

Chemical Plant, France

August 2010

Gutter for collecting spills in a truck unloading area for Caustic soda and Hydrochloric acid.

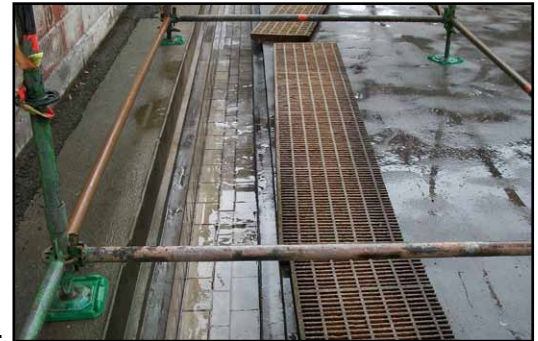
The original gutter was made of tiles which became soft and porous.

1. Damaged gutter
2. New steel gutter ready to be installed
3. Steel gutter grouted into place with Belzona® 4151
4. Belzona® 4311 applied to completely seal grout and surrounding concrete
