BELZONA REPAIRS SHAFT FROM CRUSHER

Non-metallic Materials Industry, Russia

December 2009

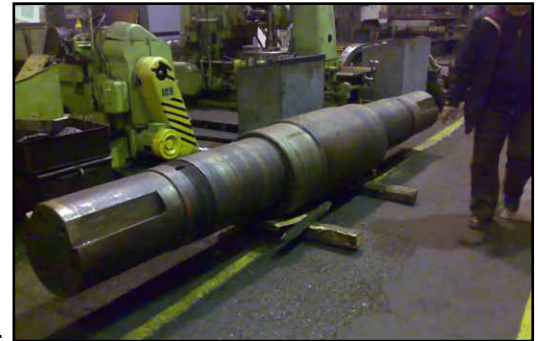
Shaft of 4.6 m length and weighing 7,2 tonnes from crusher which is critical part of the minerals plant.

1. General view of the eccentric shaft of crusher
2. Area before the application
3. After surface preparation application of Belzona® 1111
4. Completed application

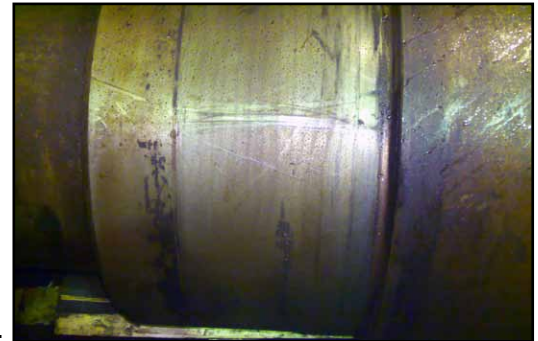
2.

Failure of bearing caused it to spin on the shaft causing it to wear undersize.

Application was carried out in accordance with Belzona Know-How System Leaflet MPT-1. Shaft was turned down 1.5mm undersize and left with coarse thread before being rebuilt with Belzona® 1111 followed by machining back to original diameter.
