## BELZONA SEALS GASOLINE STORAGE TANK

Petrochemical plant, Ontario, Canada

A large gasoline storage tank

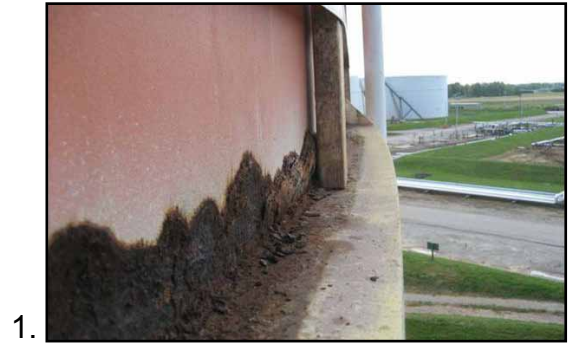
Water was collecting on this large reinforcement seam causing extensive corrosion.

1. Large corrosion area
2. Severity of corrosion clearly evident
3. Use of crane lift to access repair area
4. Completed Application

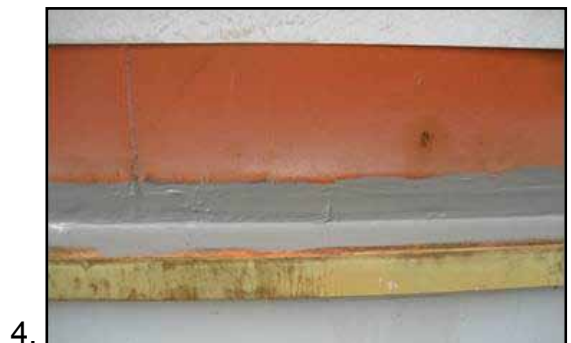
Belzona 1161 was used due to the difficulty in accessing and removing all condensation in the repair area. The application is in excellent condition until today without any problems.

Belzona 1161 (Super UW-Metal)
