BELZONA SAVES FINE PAPER PUMP CASING

Papermill, Port Elizabeth, South Africa.

Pump handling fine pulp.

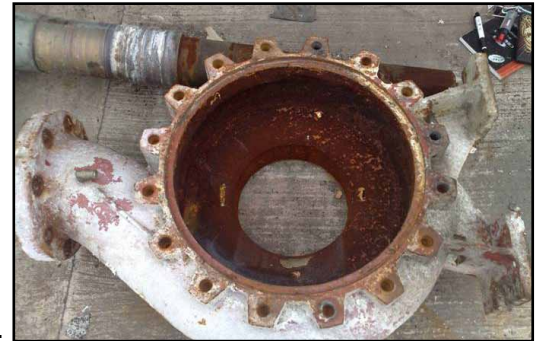
Badly corroded pump volute could not be put back in service in such bad condition

1. Corroded Pump Volute before application
2. Volute coated with Belzona® 1321
3. The refurbished pump volute ready for service

Belzona® 1321 (Ceramic S -Metal)

The application was carried out in accordance with Belzona Know-How System Leaflet CEP-5.
