## BELZONA OFFERS PROTECTION BY SEALING INSULATOR BASES

100,000 volt insulators.

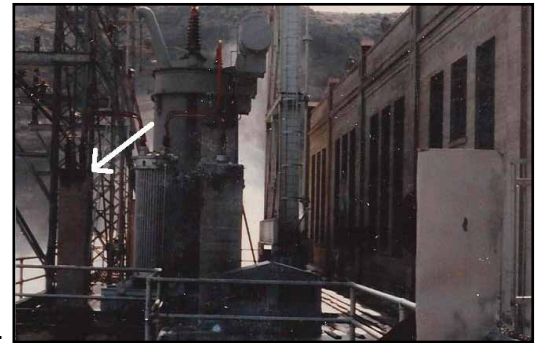
The bases of the insulators had been sealed and re-sealed many times but it never lasted long, thus water would begin to leak through the base. The switch gear below carries 100,000 volts of electricity which would not react well if the water hit the wrong spot.

1. Arrow shows damaged area
2. Applying Belzona 3911
3. Brushing on reinforced Belzona 3111
4. Brushing on reinforced Belzona 3111

Loose tar was removed. Belzona 3911 was brushed on the concrete and Belzona 3921 was brushed on the insulator. Two coats of Belzona 3111 were brushed on, incorporating reinforcing sheet in the first coat. The application was carried out in accordance with a modified version of Belzona Know-How System Leaflet GSS-3.
