BELZONA REPAIRS PILLOW BLOCK SHAFT

Sawmill shaft.

Seized bearing on 20' shaft. Replacing the shaft would be time consuming, shutting down the entire sawmill for hours.

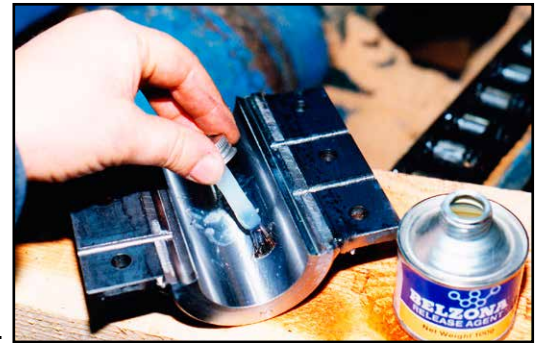
1. Applying Belzona 9411 to the former
2. Sweating the oil out of the steel shaft using a torch
3. Bolting the former in place
4. Dressing down Belzona 1111 with emery cloth

A former was made at the in-house machine shop in accordance with a modified version of Belzona Know-How System Leaflet MPT-2. Note the relief grooves down the side of the flanges. The former received two coats of Belzona 9411, then Belzona 1111 was applied. The shaft was ground and Belzona 1111 was applied. The former was bolted in place and Belzona 1111 was allowed to cure. After 2 hours, the former was removed, the excess of Belzona 1111 was dressed down with emery cloth and the new bearing installed.
