DAMAGED LOADING BAY STAYS STRONG WITH BELZONA

Industrial gas supplier, UK

Concrete loading area for gas cylinders.

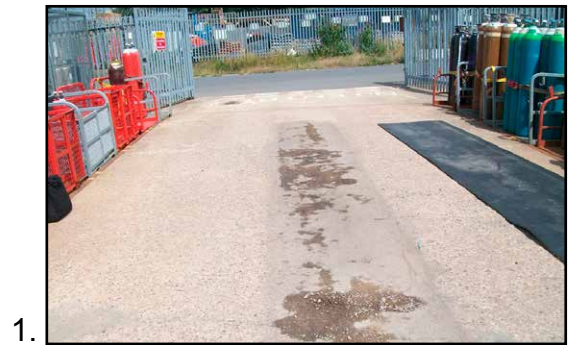
The surface of the concrete ramp had become damaged due to impact from the gas cylinders when being loaded and unloaded, even though they are dropped onto a rubber mat. The uneven surface was making it increasingly difficult for the tall narrow cylinders to stand up safely.

1. 8.5m x 5m concrete loading area damaged by impact
2. Extent of the damage
3. Repaired with 6mm of Belzona 4131
4. Application revisited almost 3 years on

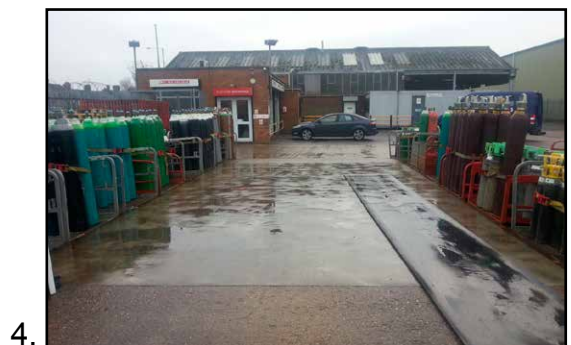
This is a common problem on many gas distribution sites across the UK. Belzona was selected firstly for its ability to protect against impact and abrasion. Secondly for being impermeable and resistant to frost damage. The loading area has been revisited almost 3 years later and after almost 3 years of constant loading and unloading of gas cylinders the application area is still in excellent condition.
