BELZONA REPAIRS AND COATS RUBBER SOCK

Rubber sock that dispenses concrete into the trucks.

The rubber sock was worn.

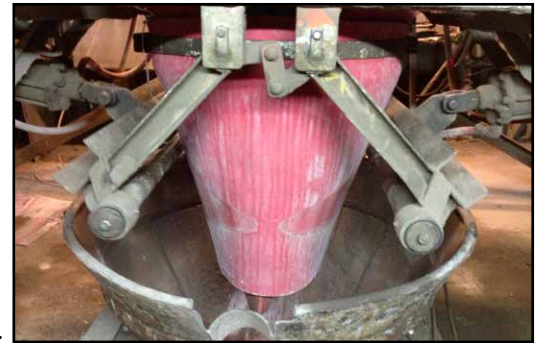
1. Rubber sock
2. Prior to application
3. Complete preparation
4. Completed application
