BELZONA PROTECTS STERN TUBE

APPLICATION SITUATION
Stern tube in a US Army Ship.

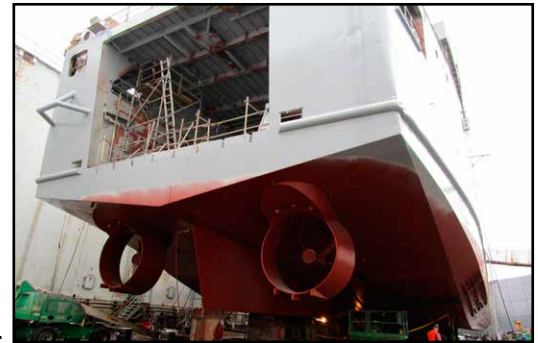
1. Stern of the ship
2. Inspecting the grit blast
3. First coat of black Belzona 5811
4. Second coat of gray Belzona 5811
