BELZONA'S SHAFT REPAIR RESTARTS PRODUCTION

Shingle manufacturing machine.

Shaft was worn and damaged.

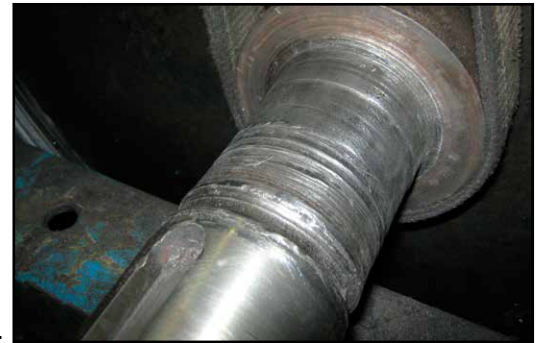
1. Damaged shaft
2. Completed preparation
3. Application in process
4. Completed application
