BELZONA IMPROVES SAFETY WITH NONSKID SURFACE

Slippery steps.

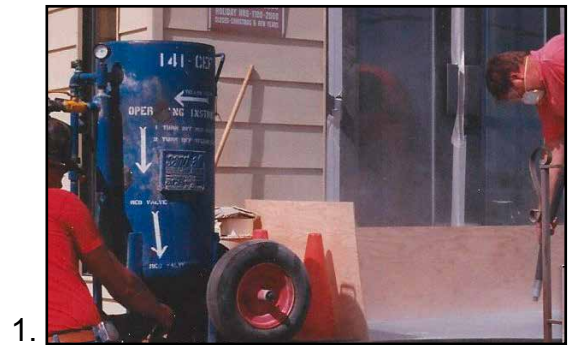
1. Blasting the concrete
2. Brushing on Belzona 4411
3. Sprinkling on Belzona 9221
4. Completed application

Application was carried out in accordance with Belzona Know-How System Leaflet FPA-8. The surface was blasted to remove all surface laitence. Belzona 4411 was brushed onto the surface and Belzona 9221 was spread on top.
