BELZONA OFFERS THE KEYWAY TO SUCCESS

Large punch press keyway.

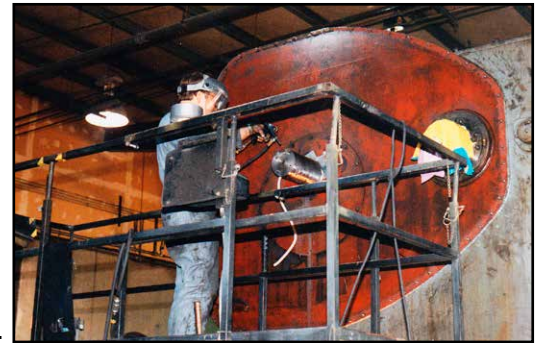
1. Punch press, blasting the keyway
2. Before sheave removal, showing damage to the keyways
3. Forming the sheave keyway
4. Forming the shaft keyway

Both halves of the keyway were worn, but the shaft was worn more than the sheave. The keyway was grit blasted for maximum bonding. The sheave side was formed first then the shaft was formed, using the sheave to center the new keyway. The application was carried out in accordance with Belzona Know-How System Leaflet MPT-4.
