BELZONA STEPS UP TO THE CHALLENGE

Stairs to a municipal recreational center.

Spalled concrete around hand rail post.

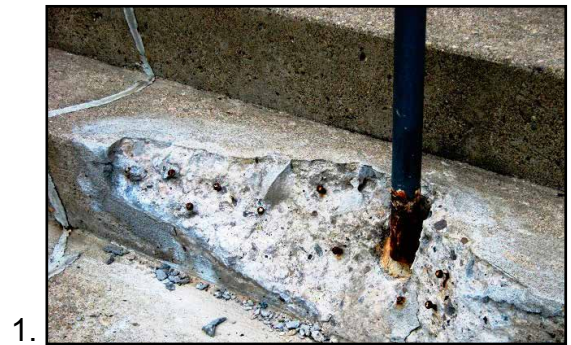
1. Prior to application
2. Preparation in process
3. Application in process
4. Completed application
