BELZONA SAVES HEAT EXCHANGER FROM COSTLY REPLACEMENT

APPLICATION SITUATION
Heat exchanger covers.

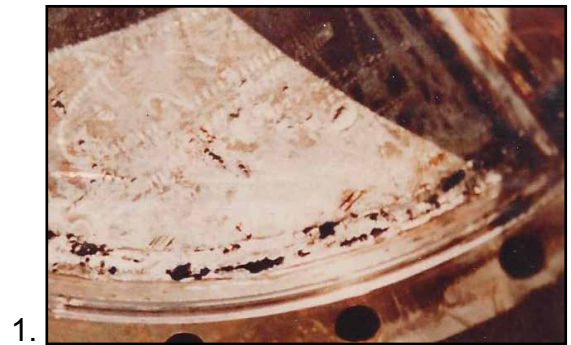
PROBLEM
All ten heat exchangers had been replaced just one year ago. The covers were stainless steel but were welded with a carbon steel rod, setting up electrolysis. Replacements would take more than 3 months to build and a cost of downtime at \$70,000.00 per day. With Belzona, all ten were rebuilt in just seven days. They were opened one year later and the heat exchangers were found to be in perfect condition.

- PICTURES**
1. End cover showing electrolysis
 2. Close up of damage
 3. & 4. Completed application on end cover
