BELZONA SAVES DRAIN DAMAGED BY CHEMICALS

Damaged concrete in kitchen drain.

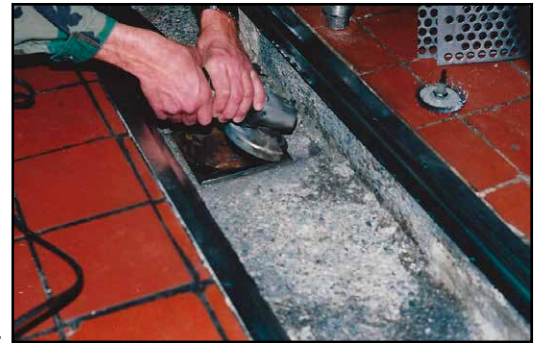
Chemicals used to clean equipment in the kitchen were destroying the concrete in the drain.

1. Grinding the steel drain
2. Conditioning the concrete
3. Troweling in the Belzona 4111
4. A coat of Belzona 4311 brushed over the drain surface

The application was carried out in accordance with Belzona Know-How System Leaflet FPA-3. The concrete was cleaned and the steel was ground. Belzona 4111 was troweled over the area. A coat of Belzona 4311 was brushed over the surface, including the steel drain, to protect from chemical attack.
