BELZONA SEALS SKYLIGHT TO PREVENT WATER PENETRATION

A skylight on the roof of a building.

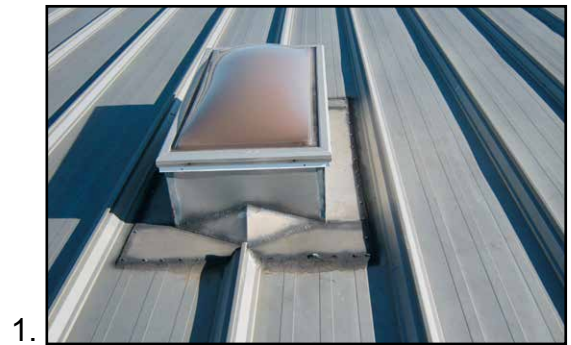
Water penetration between roofing sheets and around the skylight.

1. Prior to application
2. Preparation in progress
3. Application in progress
4. Completed application
