BELZONA PROTECTS DIESEL FUEL BAY WITH NON-SKID FLOORS

APPLICATION SITUATION
Fuel bay floor at bus depot.

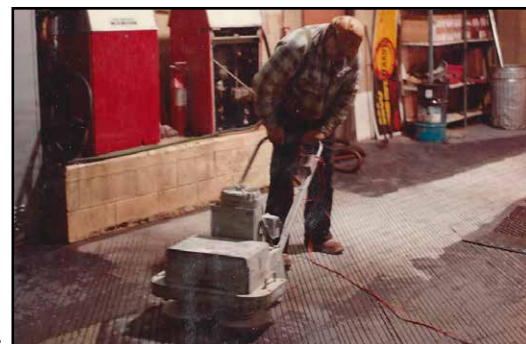
1. Grinding the surface with a stone grinder
2. Brushing on Belzona 4411
3. Completed application of test patch

APPLICATION METHOD
The floor was pressure washed to remove the remainder of previous non-skid products and the spilled diesel fuel. A propane torch was used to lightly heat the concrete, drawing out more diesel fuel from the concrete. The floor was pressure washed a second time. A stone floor grinder was used to remove the surface laitance then Belzona 4411 was brushed on, sprinkling aggregate on top. The application was carried out in accordance with Belzona Know-How System Leaflet FPA-8.
