BELZONA PROTECTS AIR DIFFUSER AGAINST CORROSION

An air diffuser in a warehouse.

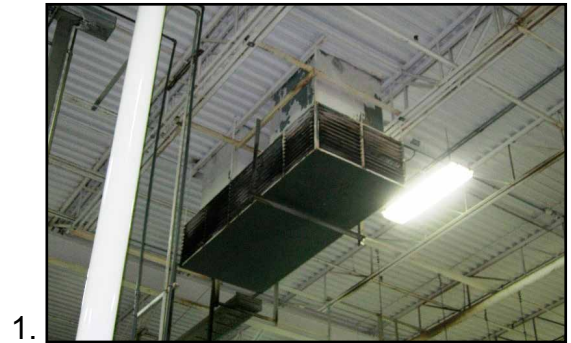
The sheet metal on the air diffuser was suffering from corrosion.

1. Air diffuser
2. Prior to application
3. Application in process
4. Completed application
