BELZONA PROTECTS ACID VESSEL FROM CHEMICAL ATTACK

Acid production vessel.

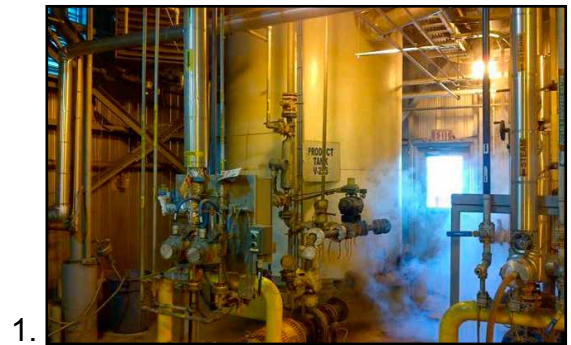
1. Acid vessel
2. Prior to application
3. Application in progress
4. Completed application

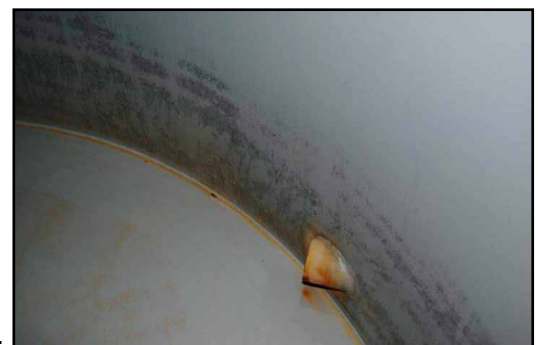
The acid had damaged the Teflon coating.
