BELZONA REPAIRS BUSH HOUSINGS

Log loader bush housings.

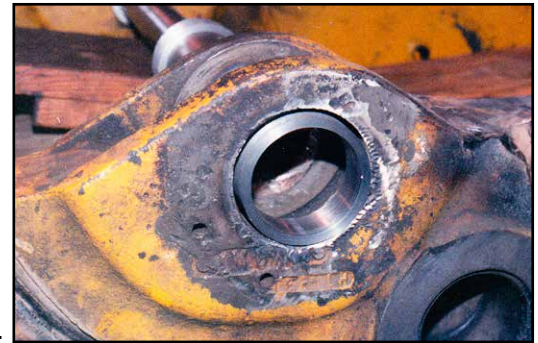
The bush housings were worn oversize.

1. New bushings set in to show amount of wear
2. Grit blasting the housings
3. Bushings in place with shaft for alignment
