BELZONA REPAIRS LEAKING PIPE IN ABRASIVE ENVIRONMENT

Circa. 177mm O.D. Leaking Pipe

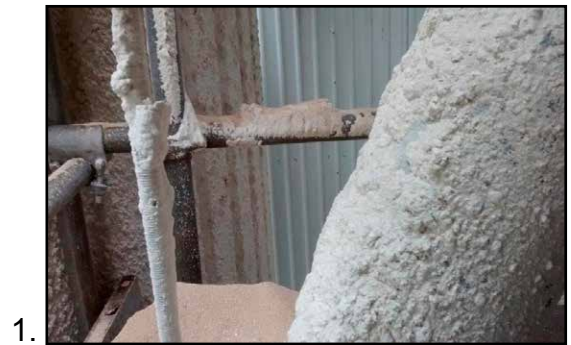
The dry bran within the pipe was causing abrasion leading to a 10mm hole on the outside of a large bend.

1. Holed pipe
2. Belzona 1812 being applied over Belzona 1321
3. Completed Belzona 1812 Application
4. Excess Belzona 1321 Application
